Shop Tips

NOVEMBER, 1963

FROM FORD

Technical parts and service information published by Ford Division to assist servicemen in Service Stations, Independent Garages and Fleets.

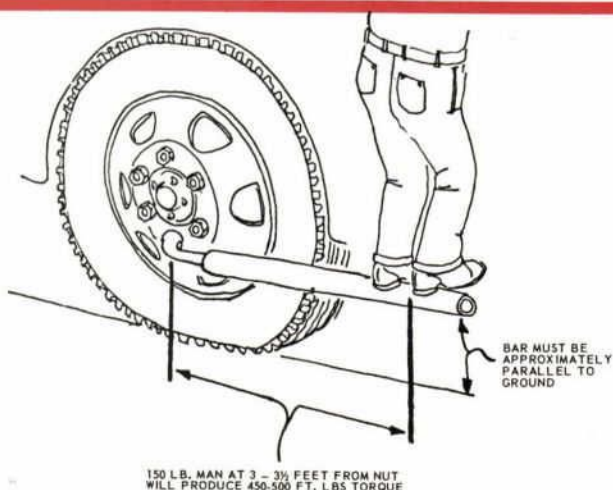
Fig. 1—500-800 Series Truck Wheel Nut Tightening Emergency Procedure

Retaining nuts on Ford 500-800 series truck disc wheels will loosen if not properly tightened. Correct torque for these wheel nuts is 450-500 ft. lbs., and only wheel nuts which are tightened to this specification will remain tight under vehicle operation.

For proper tightening, a 500# capacity torque wrench (any one of many models offered by Snap-On, Proto, Sturtevant, Richmond, etc.) should be used. In the absence of such wrenches, the wheel nuts can be tightened to approximately correct specifications by use of an extended lever wrench. The full weight of a 150 pound man at the end of a 3 foot or 3½ foot wrench bar (held horizontally) will produce 450-500 ft. lbs. (See Figure 1).

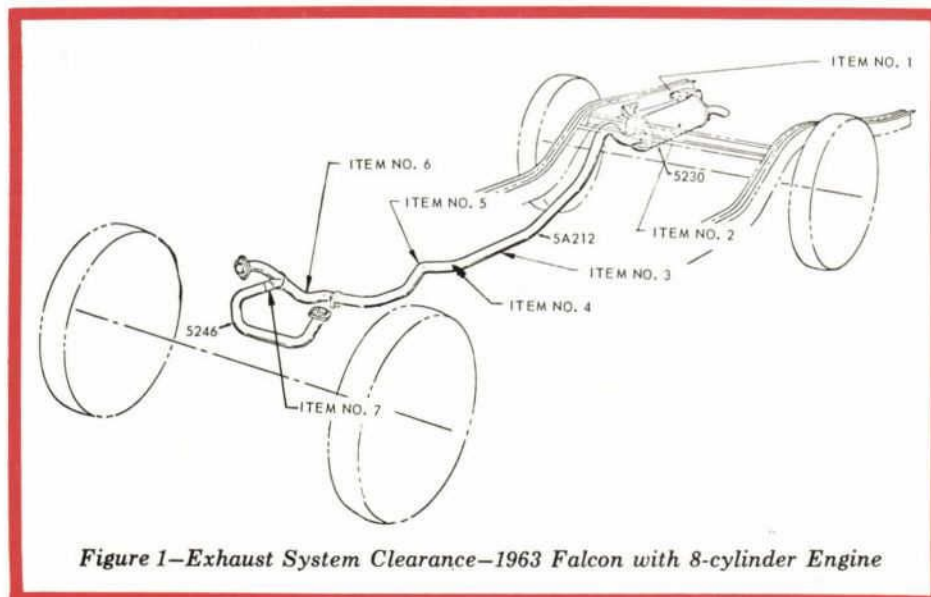
Figure 1—Exhaust System Clearance—1963 Falcon with 8-cylinder Engine

7. A clearance of $\frac{1}{2}$ " should be maintained between the flat on the muffler "Y" pipe and the power steering hoses.

The above areas are indicated in Figure 1 for clarification of location.

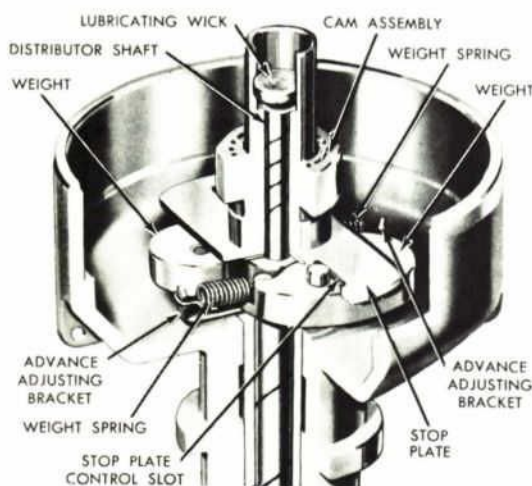
Figure 1—Centrifugal Advance Mechanism

The new primary and secondary distributor centrifugal weight springs—Figure 1 (next page)—increase the rate of advance during acceleration or when there is a heavy load on the engine. When the engine is operated under a light load, the new vacuum diaphragm spring—Figure 2, provides additional advance which is required for maximum part throttle power and economy. The vacuum advance stop—Figure 2—is required to limit the maximum spark advance.

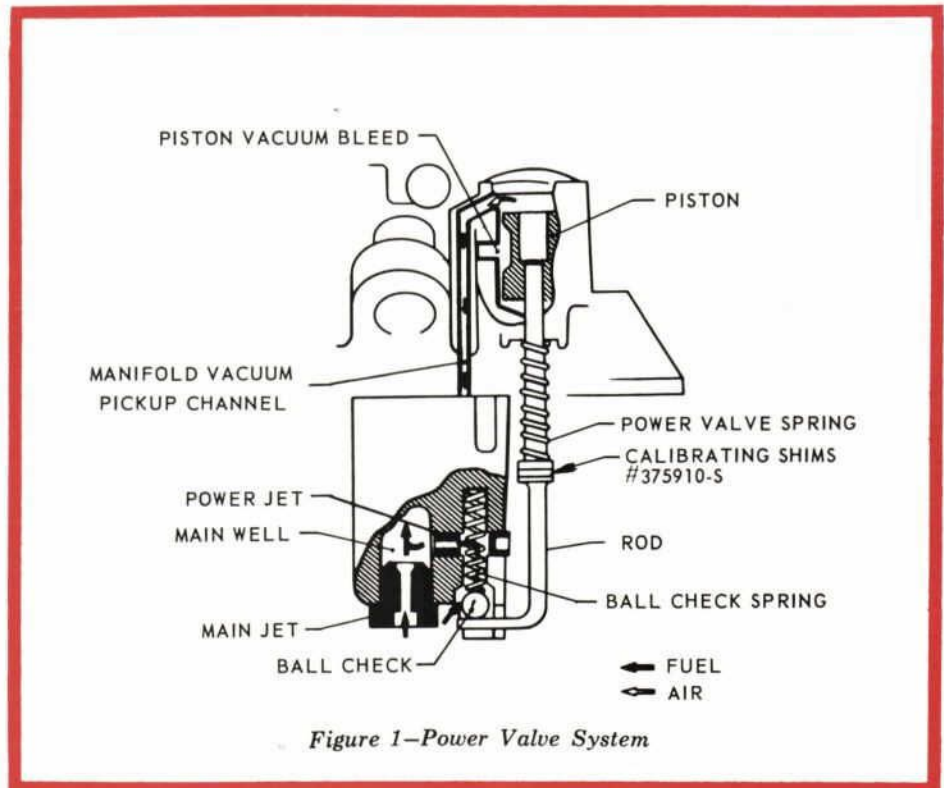
Figure 1—Power Valve System

Vehicle surging or hesitation at part throttle steady speed or wide open throttle operation, caused by an excessively lean fuel mixture may be encountered on 1963 Econolines with both the 144 and 170 engines. Design specifications for the carburetor favor the lean side for fuel economy but under certain operating conditions may affect smooth engine operation.

The carburetor can be modified to correct the lean mixture and surging problem by installing a main metering jet one number size larger and by changing the power valve timing to open sooner (at less throttle opening).

The power valve timing change can be accomplished by installing four additional calibrating shims (Ford Part No. 375910-S) on the power valve rod, see Figure 1. Under no condition should the total number of shims exceed 8, as fuel economy will be adversely affected. If more than 4 shims exist on the power valve rod as installed in production, then fewer additional shims should be used so that the total amounts to only 8 shims.

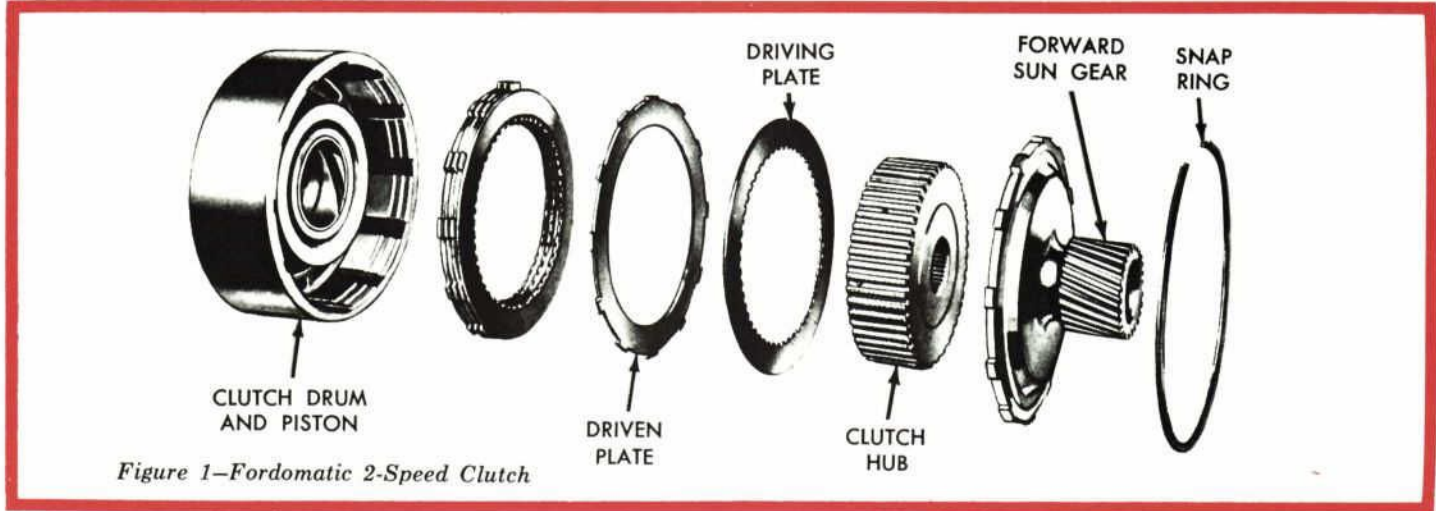
Figure 1—Fordomatic 2-Speed Clutch

Clutch plate failures on Fordomatic two-speed transmissions can be caused by failure of the snap ring which retains clutch pack and sun gear in the clutch drum. See Figure 1. This snap ring may have lost its tension due to

gust, 1963, which encounter clutch failure, the snap ring existing in the assembly should not be reused. A new snap ring (Ford Part No. B9A-77523-A) should always be installed. Furthermore, subsequent failure of the clutch pack because of this snap ring can be prevented by making it a practice to replace this snap ring whenever the transmission is disassembled for any internal repairs.

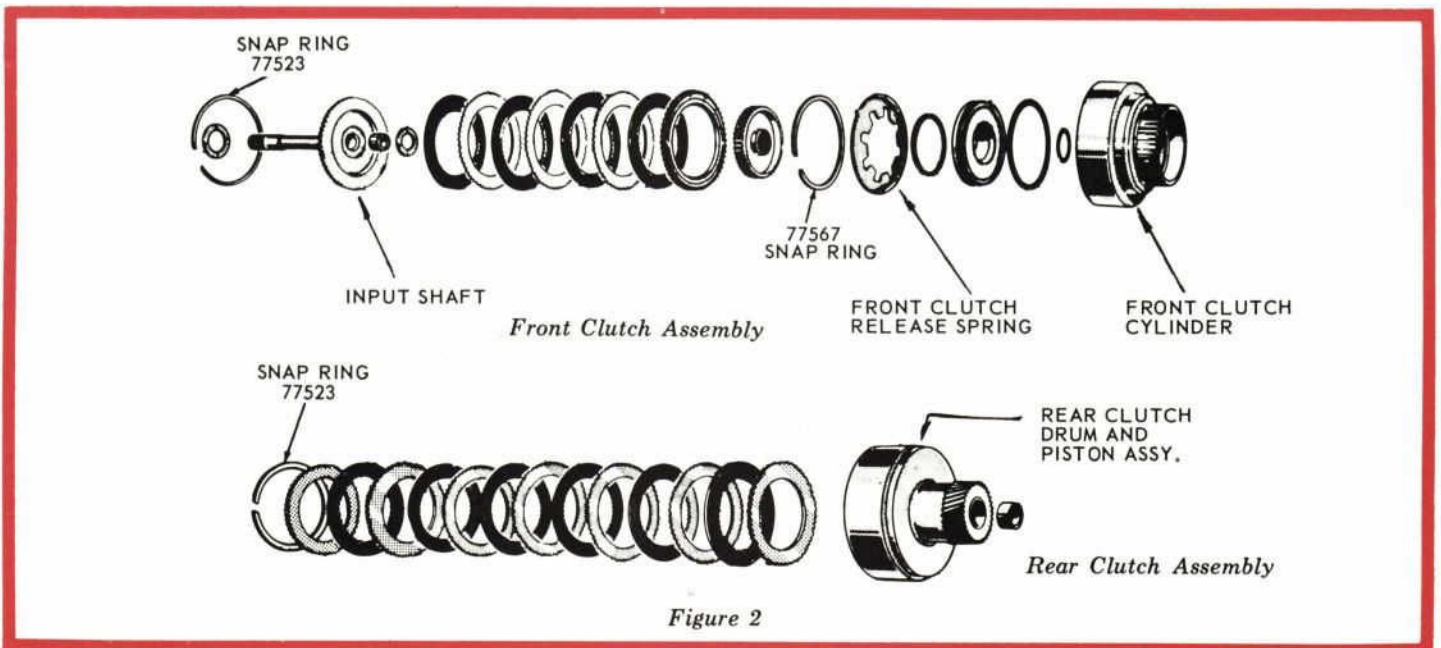
Figure 2

Clutch plate failures on Cruise-O-Matic transmissions can be caused by failures of one or all of the following snap rings: the input shaft to front clutch cylinder snap ring, the front clutch release spring to front clutch

cylinder snap ring and the rear clutch pressure plate snap ring. See Figure 2. These snap rings may have lost their tension due to the influence of high temperature, and may come free from the retaining groove in the clutch cylinder and/or drum. This allows the clutch pressure plates (front or rear) and/or clutch release spring to move out of the cylinder or drum with a resultant loss of compression and slippage of the clutch pack upon piston application.

On transmissions built before mid-August, 1963, which encounter clutch failure, the snap rings existing in the assemblies should not be reused. New snap rings should always be installed. Furthermore, subsequent failure of the clutch packs because of these snap rings can be prevented by making it a practice to replace these snap rings whenever the transmission is disassembled for any internal repairs.

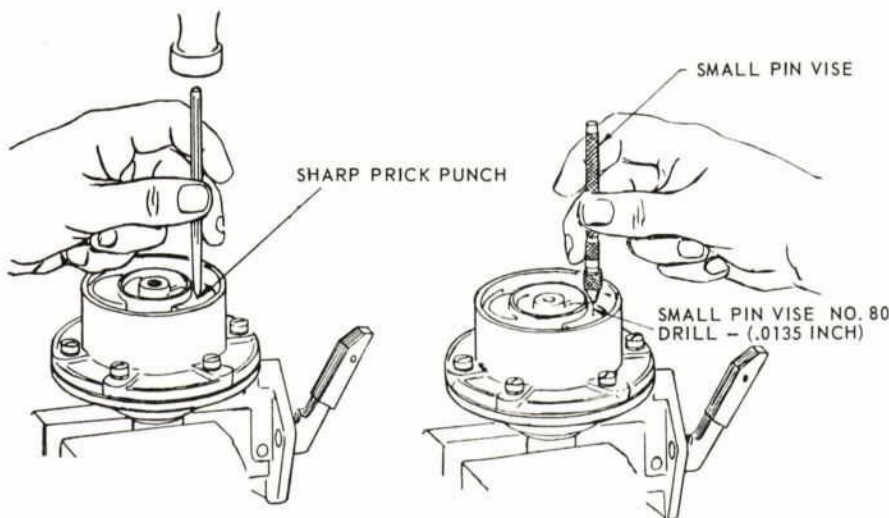
Figure 1—Bleed Hole—A/C Type Fuel Pump

Hard hot engine starting is generally caused by fuel percolation in the carburetor main well, or excessively high pressure build-up in the fuel line between the pump and carburetor. The high pressure build-up results from the hot soak period. The percolation is aggravated by the highly volatile fuel and the retention of pressure in the fuel line.

Thus, where normal carburetor adjustments do not alleviate the problem, the difficulty can be greatly minimized, and in most cases eliminated by incorporating a pressure leakdown bleed between the pressure and inlet side of the fuel pump. This will reduce the amount of available fuel that can be forced into the carburetor after engine shut down. It has been determined that the bleed hole must be a minimum size—.0135" in diameter, a number 80 drill.

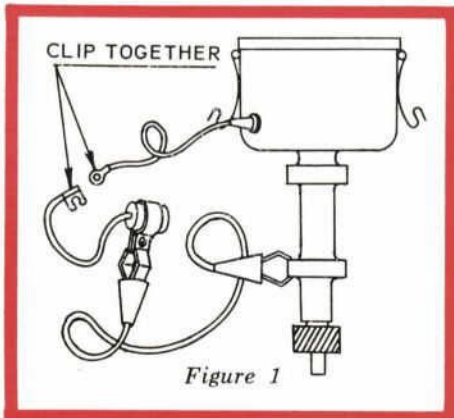
One of the desirable features of Transistor Ignition is the absence of pitting or ignition contact-point contamination. This is possible because of the low current and voltage requirements of the system. However, when checking the transistor ignition distributor on a test machine, the conventional system hook-up may cause point contamination.

Since there is no condenser in the transistor ignition distributor, it will be necessary to incorporate one in the circuit when using a distributor test machine.

Figure 1 illustrates one manner in which this may be accomplished. Any of the current Ford distributor condensers can be used, since both car and truck have the same capacity. This is 0.21 to 0.25 microfarads.

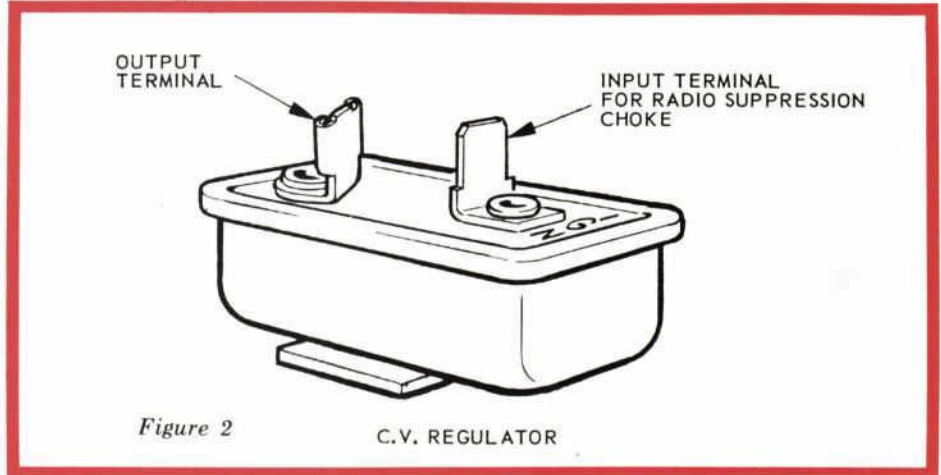
Figure 2

However, the terminal of the suppression choke is such that it can be installed on the gauge side (output), resulting in low gauge readings.

Before making gauge tests and/or replacements to the fuel, oil pressure, and temperatures systems on vehicles equipped with AM-FM radios, check the radio suppression choke to be sure it is connected to the ignition side (input) of the C.V. regulator. See Fig. 2.

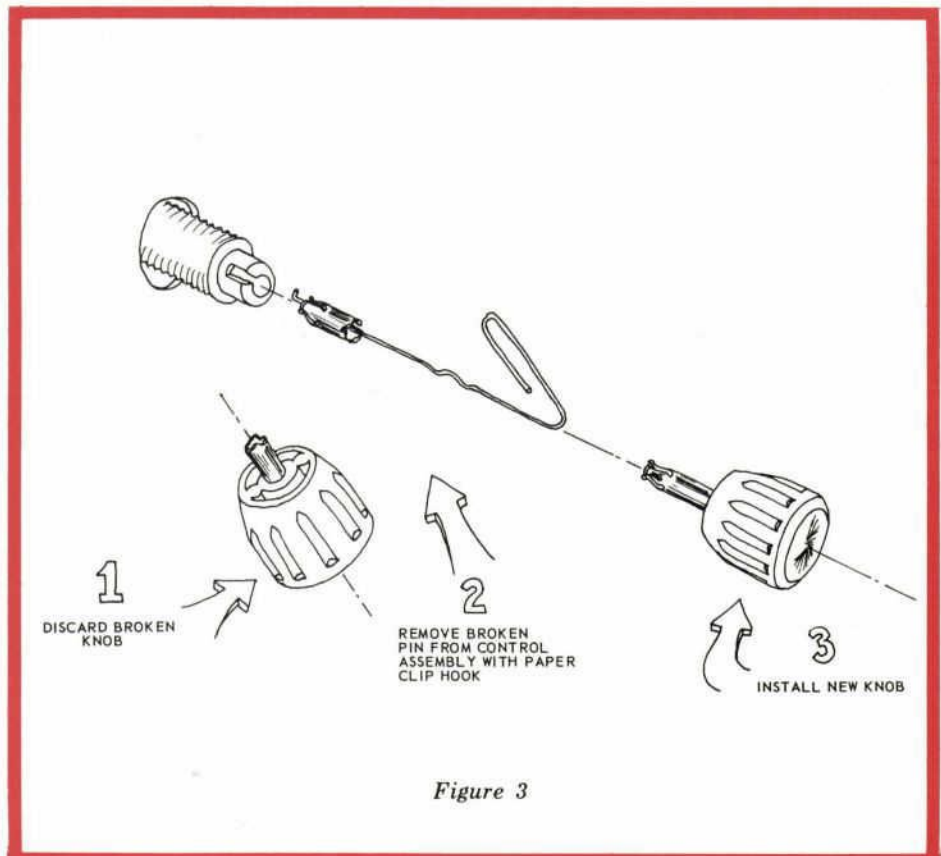
Figure 3

Examination of samples of the above knobs indicates that many failures are due primarily to damage. The damage and resultant failures are attributed to the neglect of the mechanic in removing the broken control knob pin from the control assembly prior to installing a new control knob.

The broken control knob pin can easily be removed from the control cavity by bending a paper clip to form a small hook on one end. Insert the hooked end into the center of the broken pin and pull outward to remove. See Figure 3.

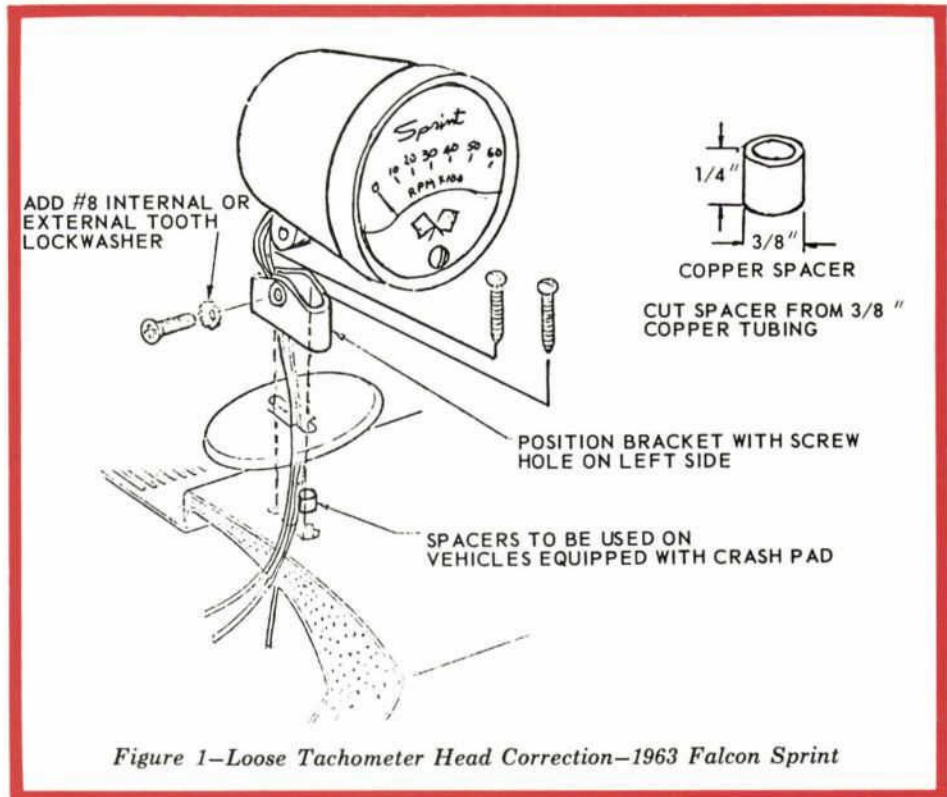
Figure 1—Loose Tachometer Head Correction—1963 Falcon Sprint

Loose tachometer heads and mounting plates have been encountered on 1963 Falcon Sprints built prior to May 1, 1963. The loose heads are caused by loss of torque of the adjusting screw and are usually found on vehicles without a crash pad. This can be corrected by the addition of one #8 tooth lockwasher as shown in Figure 1.

A loose mounting plate on a vehicle with a crash pad is caused by the compressibility of the crash pad material. This has been corrected by use of a spacer that will give solid support to the mounting plate.

1. Remove tachometer and mounting bracket.
2. Cut a $\frac{1}{4}$ " length of $\frac{3}{8}$ " O.D. copper tubing to be used as a spacer at rear mounting hole.

3. Cut out crash pad vinyl and foam around rear instrument panel hole to permit spacer to seat onto instrument panel metal.

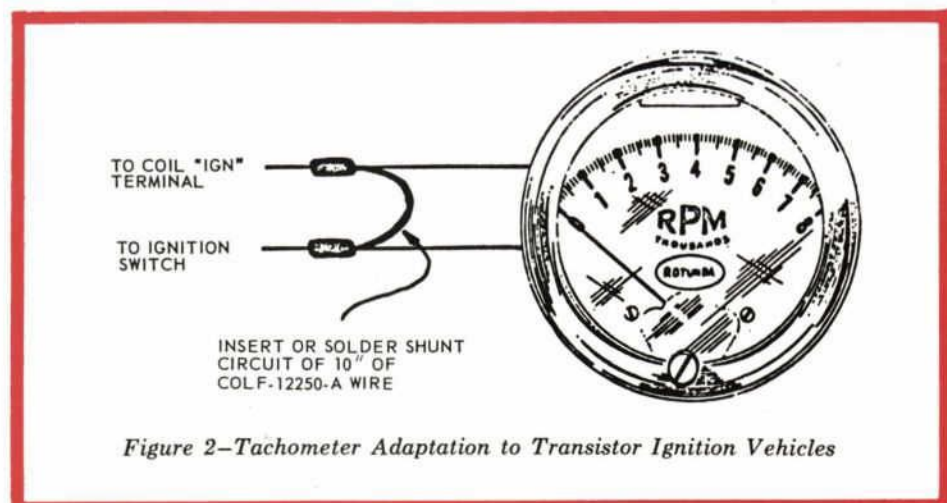
Figure 2—Tachometer Adaptation to Transistor Ignition Vehicles

Failure of a tachometer can occur on vehicles equipped with a transis-

torized ignition system because of the higher current draw of these systems. This is true of all transistor systems.

To prevent these failures, a shunt circuit should be installed across the tachometer leads as shown in Figure 2. This shunt can be fabricated from 10" of Ford Part No. COLF-12250-A ignition resistor (pink) wire.

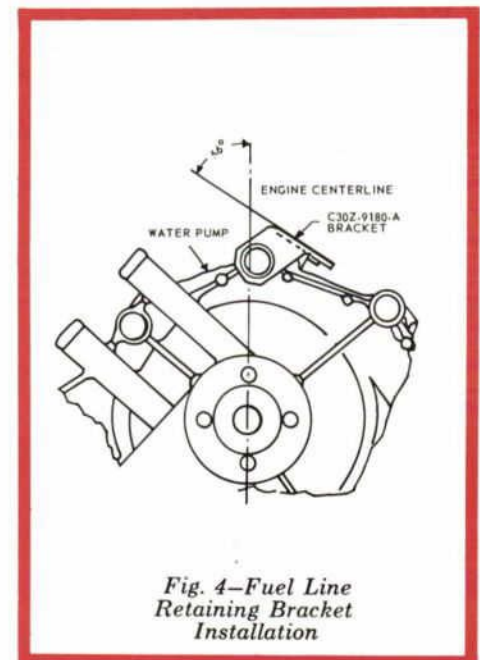
Fig. 4—Fuel Line Retaining Bracket Installation

Fuel line vibration and resultant failure of the line between the fuel pump and the carburetor can occur on vehicles equipped with the subject engines; particularly when operating on rough surfaced roads. For this reason, a fuel line bracket was used in late 1963 production and has been made available for correcting such failures and reducing fuel line vibration.

The bracket is to be installed on the water pump upper retaining bolt as shown in Fig. 4.
