Shop Tips

NOVEMBER, 1963

FROM FORD

Technical parts and service information published by Ford Division to assist servicemen in Service Stations, Independent Garages and Fleets.

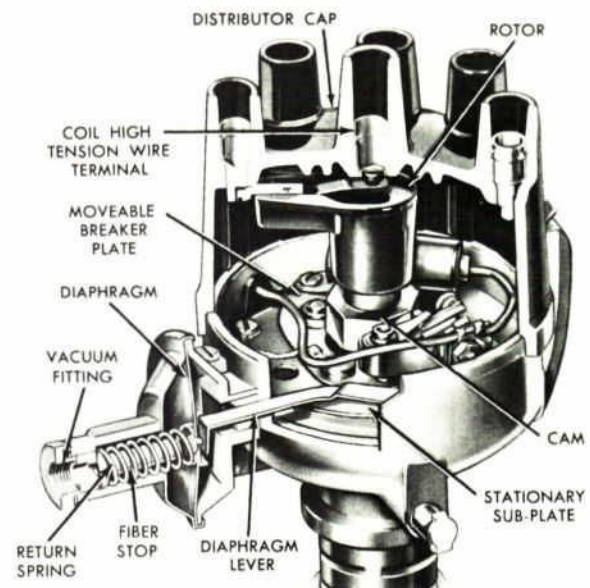
Figure 2—Vacuum Advance Mechanism

The new primary and secondary distributor centrifugal weight springs—Figure 1 (next page)—increase the rate of advance during acceleration or when there is a heavy load on the engine. When the engine is operated under a light load, the new vacuum diaphragm spring—Figure 2, provides additional advance which is required for maximum part throttle power and economy. The vacuum advance stop—Figure 2—is required to limit the maximum spark advance.
